SUBSYNCHRONOUS VIBRATION PROBLEMS IN HIGH-SPEED, MULTISTAGE CENTRIFUGAL PUMPS

Ian C. Massey

Director of Engineering

Pacific Pumps Division of Dresser Industries, Incorporated
Huntington Park, California

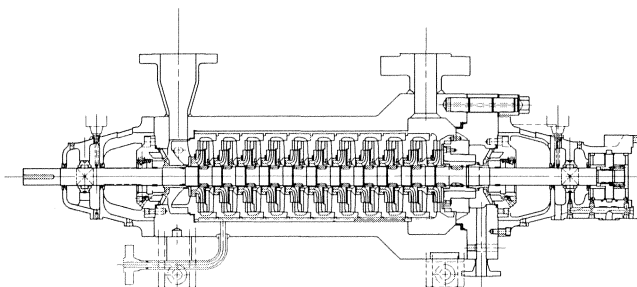
Figure 1. Eleven Stage Barrel Case Pump.

The pump design comprises an eleven stage barrel case design (Figure 1) driven by an electric motor through a gearbox at 6600 cpm pumping 470 gpm of hydrocarbon at a maximum temperature of 523°F. The hydrocarbon average specific gravity is 0.775 with a viscosity of 0.70 cp.

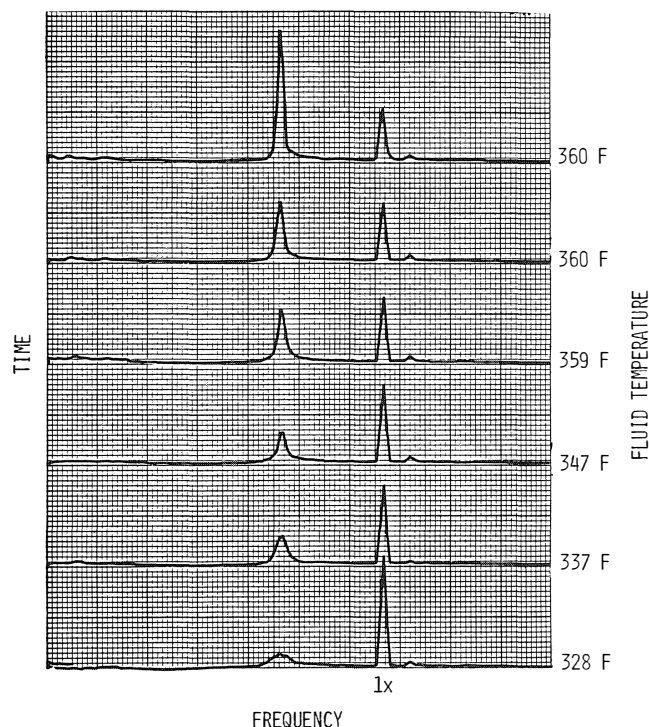
Figure 2. Subynchronous Vibration Development—Site Commissioning.

On initial startup, a low level of subsynchronous vibration was observed at the non-drive end shaft displacement transducers. As time progressed, and the temperature of the pumpage increased, the subsynchronous vibration component increased, as shown in Figure 2, to a point where it eventually swamped the synchronous signal and subsequently replaced the synchronous signal as the dominant mode of vibration.

Successive starts exhibited similar machine behavior until internal wear allowed the shaft orbit to develop vibration amplitudes which exceeded the trip setting of the vibration monitors, thus tripping the unit before full speed was attained. When the power was removed from the motor, the pump subsynchronous mode showed a frequency variation which was speed dependent, before dropping out at approximately 90 percent speed. Initially, this fact was disguised by the period of the vibration analyzer, which appeared to indicate that no speed-frequency relationship was present. The speed-frequency dependency was confirmed later by the refinery inspectors, following a comprehensive review of the available site data.
